RBR

Argo float WMO5906299: Analysis of fresh salinity anomalies

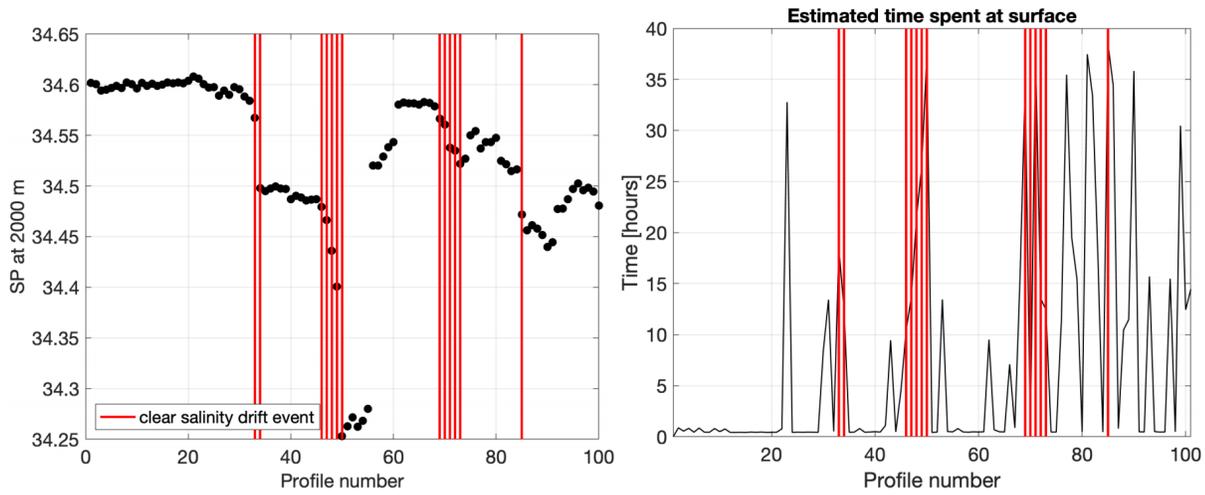
A time series of the salinity measured at 2000 dbar reveals clear and sudden fresh anomalies in the salinity (Figure 1). These fresh anomalies in salinity are confirmed in the T-S diagram including the first 102 profiles, demonstrating a homogeneous drift through depth. The homogeneity throughout the profiles suggests that the salinity anomalies are not pressure-related, but rather linked to a change in the electric field of the conductivity cell with respect to calibration (Figure 2).

The float metadata included with each profile was used to estimate the amount of time spent at the surface. The variables **TimeStartDescent** and **TimeStopProfile** were used to compute the surfacing time preceding a profile, and reveal that the float often spent an abnormal amount of time at the surface, starting at profile 23 (Figure 1). Over the first 22 profiles, time spent at the surface generally did not exceed 30 min. However, on several occasions, surfacing times were much longer: for example, the float spent over 33 hours at the surface before profile 23. While not every prolonged surfacing leads to a clear and obvious salinity anomaly, one can often link sudden salinity changes observed in the data to a prolonged surfacing time (red lines in Figure 1). This sustains the hypothesis that salinity anomalies are likely caused by biofouling developing during these extended surfacing times in tropical waters ($T > 25^{\circ}\text{C}$). This is further supported by both the direction of the anomaly (i.e., fresh), and the fact that salinity measurements at 2000 dbar sometimes "recover" (e.g., profile 56), revealing that the cause for the salinity error is reversible and thus likely external to the CTD.

This abnormal behavior has been linked to an identified malfunction in the pneumatic bladder on some Apex floats [1], which has prolonged surfacings of floats and thus likely permitted a more substantial biological growth on the CTD.

It is hypothesized that the abnormally long surfacing times of the float led to biofouling growth on the CTD. Salinity measurements collected after profile 22 should be carefully evaluated.

Figure 1: [left] Salinity measurement at 2000 dbar for each Argo profile completed by WMO5906299. Vertical lines highlight clear, sudden salinity anomalies with respect to the previous profile. [right] Estimated time spent at the surface. Salinity anomalies seem to appear after a prolonged surfacing of the float.

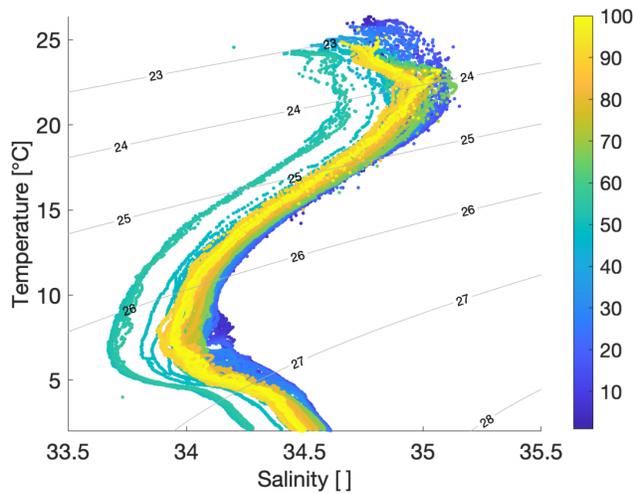
Figure 2: T-S diagram for WMO5906299, showing fresh salinity anomalies that are homogeneous throughout the water column.
